S66°20'44"W
ROXBOROUGH AVENUE
 (15'-34'-15") CITY PLAN
 LEGALLY OPEN - 60' WIDE ON CITY PLAN
 PARKING
 PARKING

GENERAL NOTES

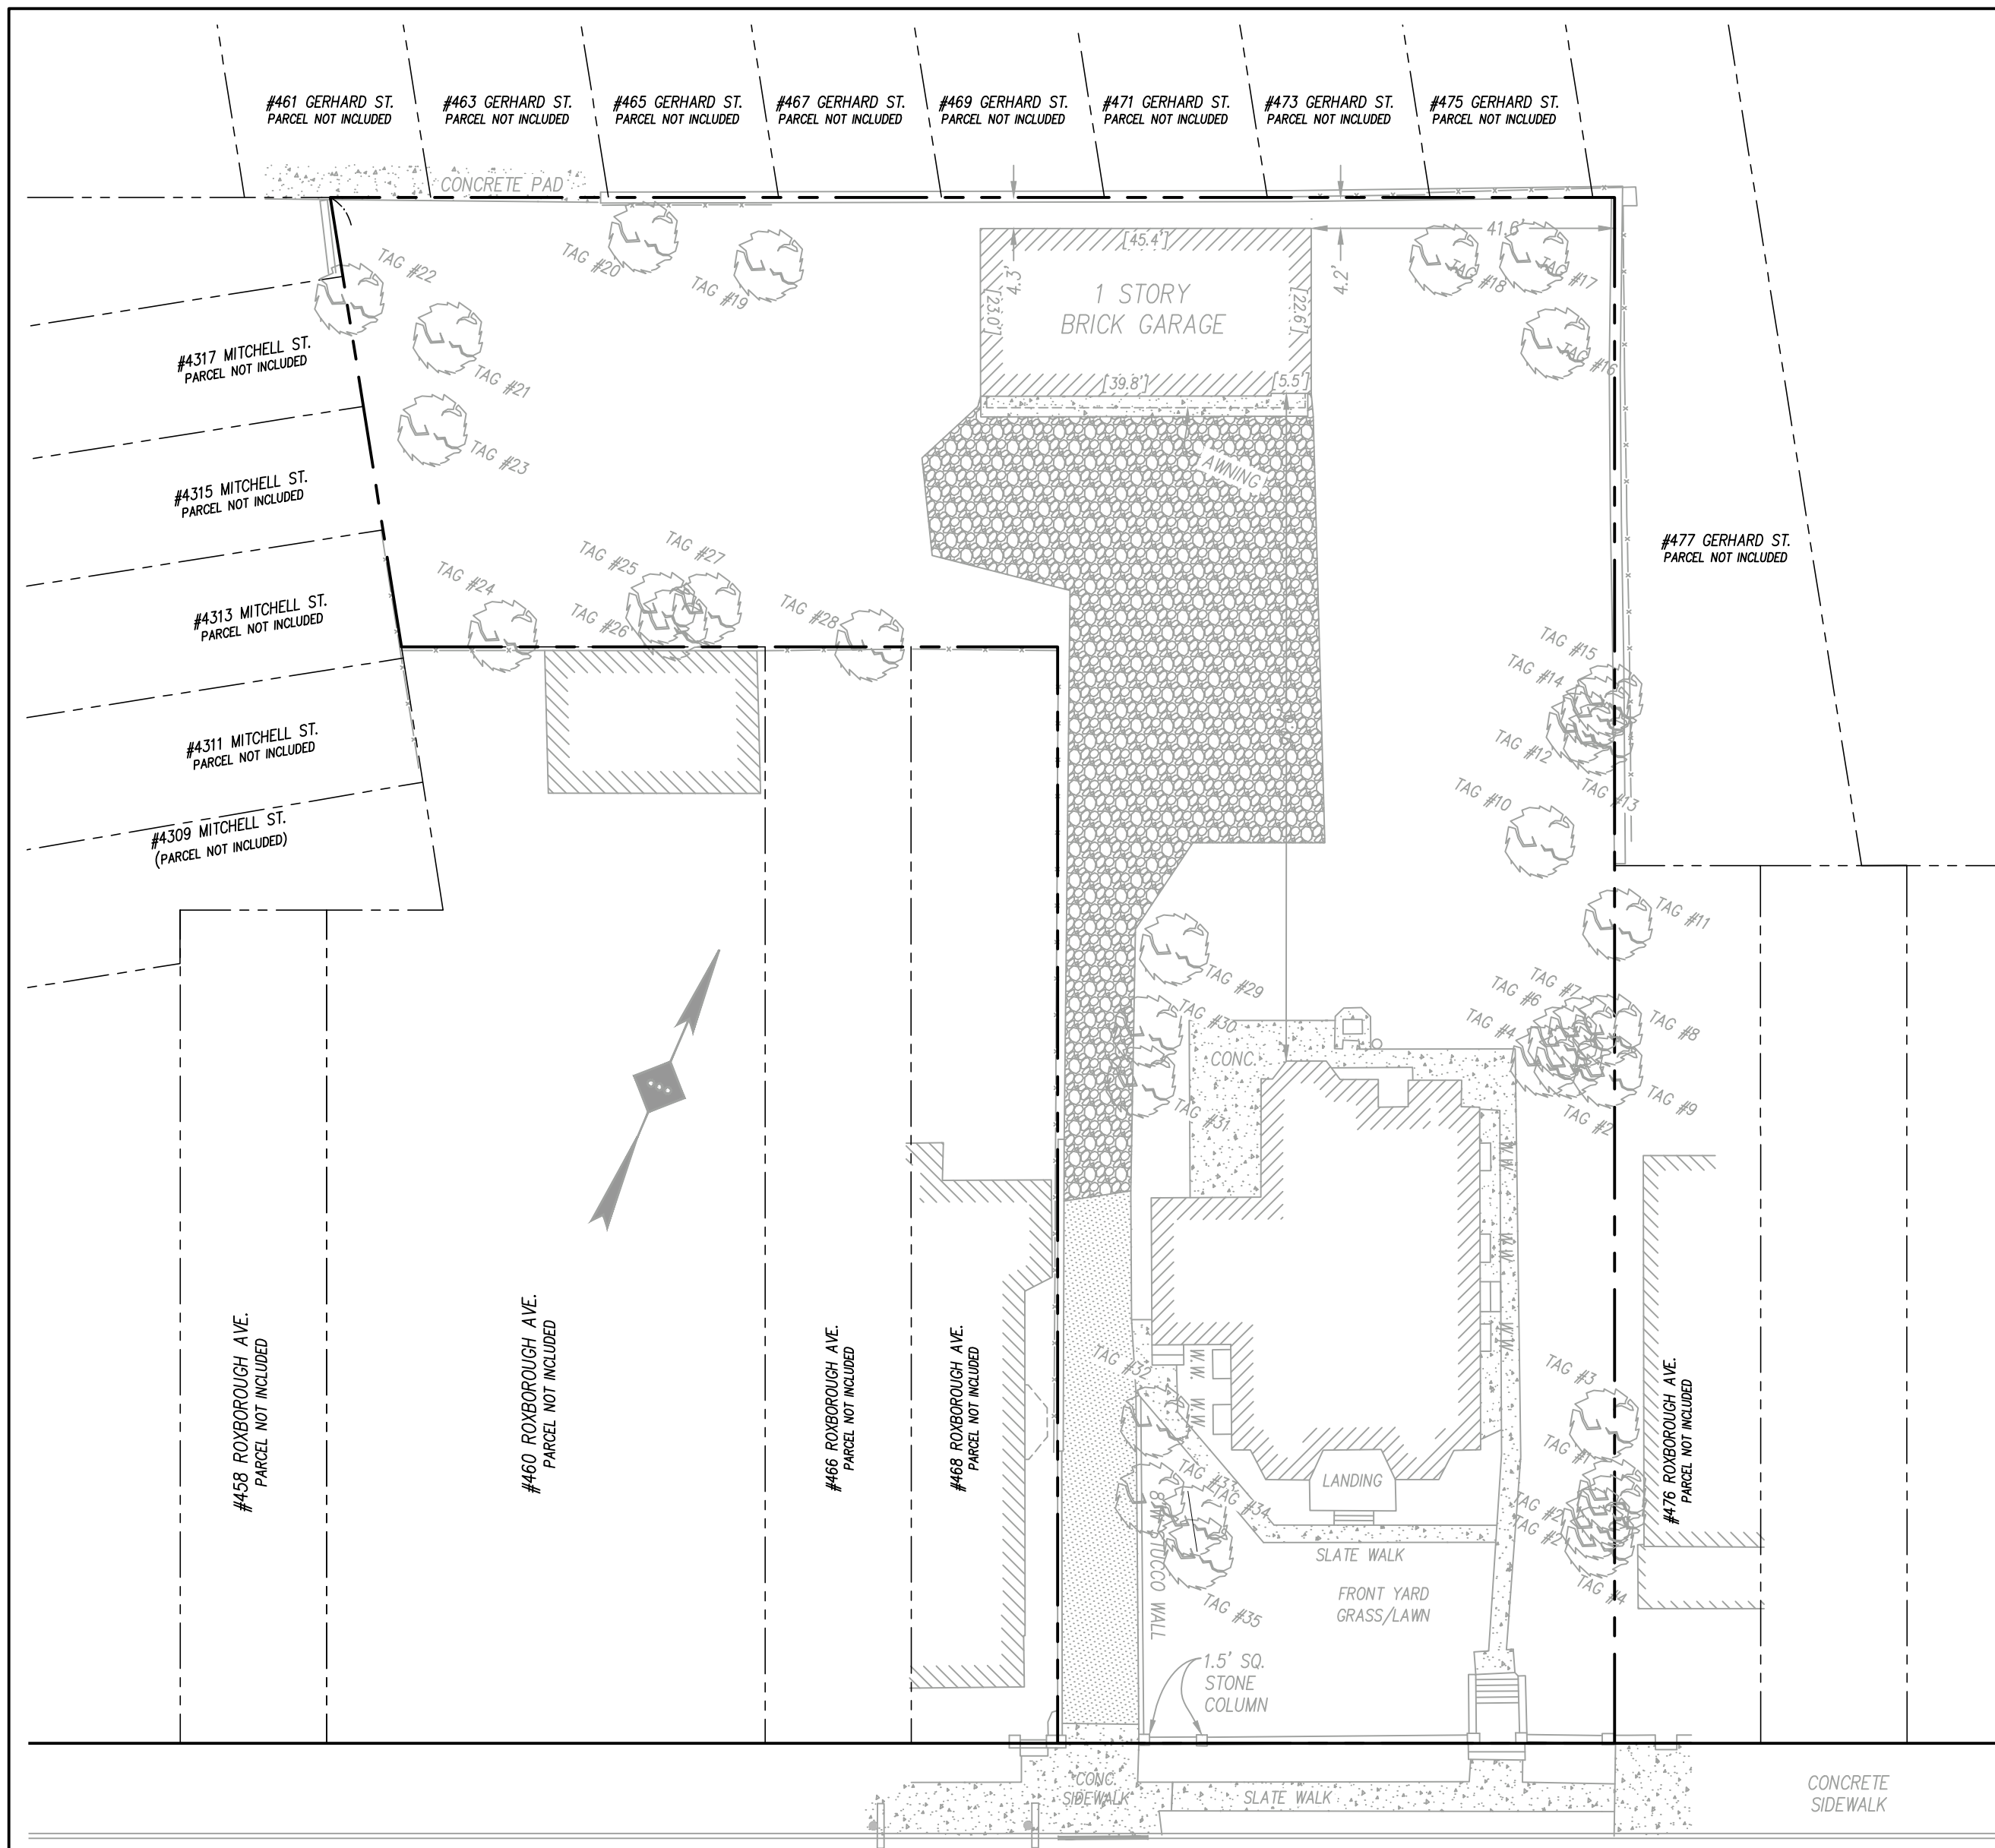
- THE SITE IS RESIDENTIAL LOT CONTAINING MOSTLY POOR STRUCTURE AND DYING TREES.
- THE SITE CONTAINS A TOTAL EXISTING TREE CALIPER OF 483 DBH INCHES FOR ALL RECORDED TREES ON SITES. THE SITE IS 0.51277 ACRES IN SIZE, RESULTING IN AN AVERAGE CALIPER DENSITY OF 942 DBH INCHES PER ACRE.

- THE TREE REPLACEMENT IN-LIEU FEE FOR SITES WITH AN EXISTING DENSITY OF MORE THAN 250 DBH INCHES PER ACRE IS \$50 PER INCH OF REMOVED TREE.
- THE SITE'S DEVELOPMENT REQUIRES REMOVAL OF ALL POOR STRUCTURE/DYING EXISTING TREES DOCUMENTED ON SITE, INCLUDING A TOTAL OF 64 DBH INCHES OF TREES THAT ARE NOT EXEMPT UNDER THE TREE PRESERVATION REQUIREMENTS.

- THE PROPOSED PLANTING PLAN INCLUDES 37.5 (ROUND TO 37) TOTAL DBH INCHES OF PROPOSED TREE PLANTINGS 2.5" CALIPER OR GREATER IN SIZE THAT ARE PROPOSED FOR PLANTING ON SITE.
